Abrasion resistance design of sediment sluicing tunnel in Taiwan: a case study

Chia-Han Lee, Shang-Shu Zhan, Shih-Hsien Chang, Shang-Yao Lien, and Jen-Hung Chang

Abstract

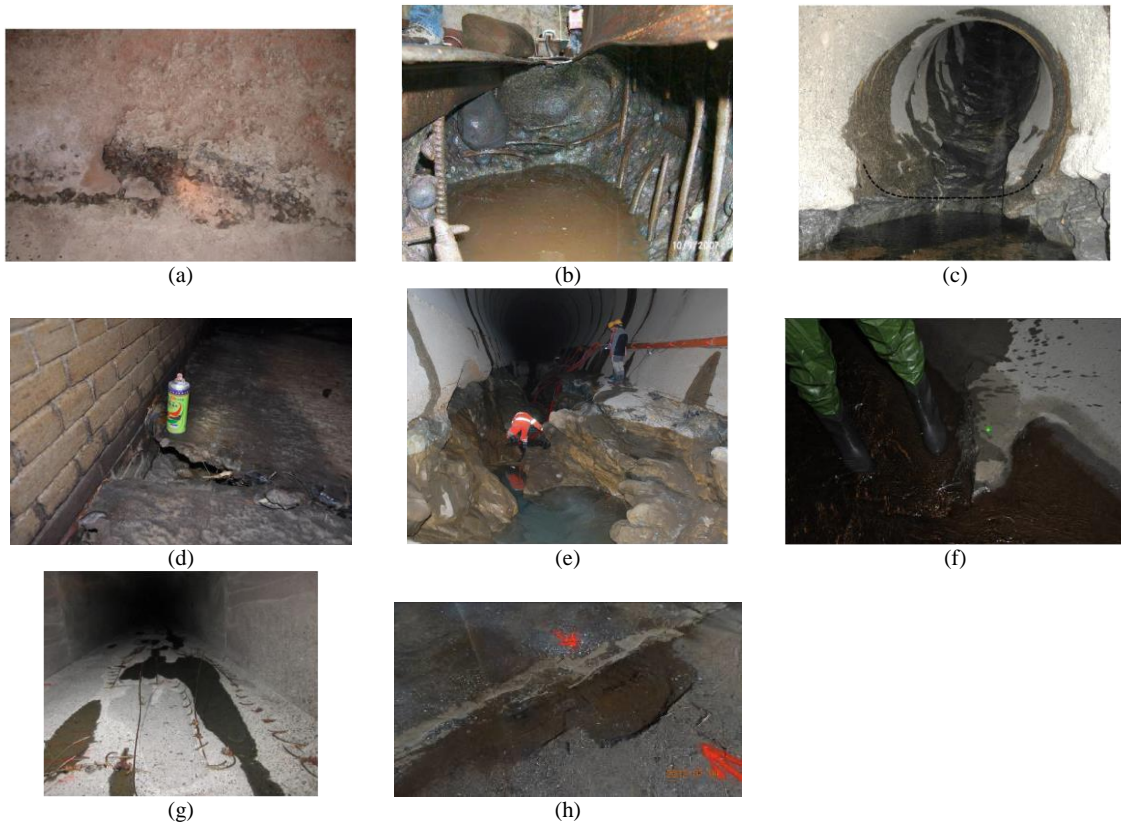
Figure 1: Case photos of invert abrasion in hydraulic tunnels: (a) Wushanling tunnel (Wang & Lee, 2013); (b) Mud Mountain tunnel (USACE, 2016); (c) Val d'Ambra tunnel (Hagmann, 2018); (d) Yuantanzi tunnel (UGI, 2013); (e) Palagnedra tunnel (Auel & Sumi, 2016); (f) Jiasian weir water delivery tunnel (UGI, 2012); (g) Asahi tunnel (Hagmann, 2018); (h) Yuanshantsu diversion tunnel (UGI, 2012).

The actual cases of hydraulic tunnel invert abrasion are summarized in Table 1 and Figure 1. It is noted that whether the tunnel invert is made of such as bedrock, bricks, concrete, reinforced concrete, steel plates, etc., under the hydrological condition of high-speed water flow with mud or gravel, abrasion may be resulted on the invert, the lining construction joints, and the spots where the tunnel turns or changes its slope.

| Country | Completion | Tunnel name | Invert material | Max. flow velocity (m/sec) | Abrasion rate (mm/year) | Photos | References |
| Taiwan | 1929 | Wushanling | Concrete | 2.1 | — | Fig. 1(a) | Wang & Lee, 2013 |
| USA | 1940 | Mud Mountain | Steel | 11.3 | 0.6 | Fig. 1(b) | Hagmann, 2018 |
| Switzerland | 1967 | Val d'Ambra | Concrete | 22 | 3 | Fig. 1(c) | Hagmann, 2018 |
| Taiwan | 1968 | Yuantanzi | Concrete | — | — | Fig. 1(d) | UGI, 2013 |
| Switzerland | 1978 | Palagnedra | Concrete | 19.7 | < 2 | Fig. 1(e) | Hagmann, 2018 |
| Taiwan | 1996 | Jiasian weir water delivery | RC (210 kgf/cm ²) | 3.35 | — | Fig. 1(f) | UGI, 2012 |
| Japan | 1998 | Asahi | RC | 13.4 | 22 | Fig. 1(g) | Hagmann, 2018 |
| Taiwan | 2005 | Yuanshantsu diversion | RC (450 kgf/cm ²) | 17 | — | Fig. 1(h) | UGI, 2012 |

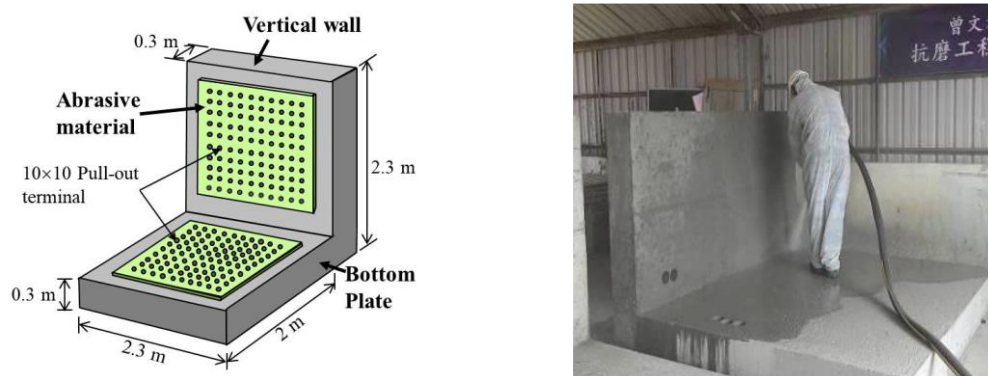
For the meso-scale in-situ tests, the concrete bottom plate and vertical wall were set up. The abrasion resistance mortar was prepared by mixing anti-abrasion epoxy resin A, B and quartz sand. The pull-out terminals were then installed on the concrete bottom plate and the vertical wall to carry out pull-out test according to ASTM D4541-02 specifications. The model size and the configuration of in-situ test are shown in Figure 4. The major failure modes can be categorized into: (1) terminal degumming failure; (2) bonding surface failure; (3) concrete failure. Overall, the bonding surface strength of the abrasion resistance material is mostly greater than 30 kgf/cm² (KTI, 2016).

Figure 4: Configuration of the in-situ pull-out test.

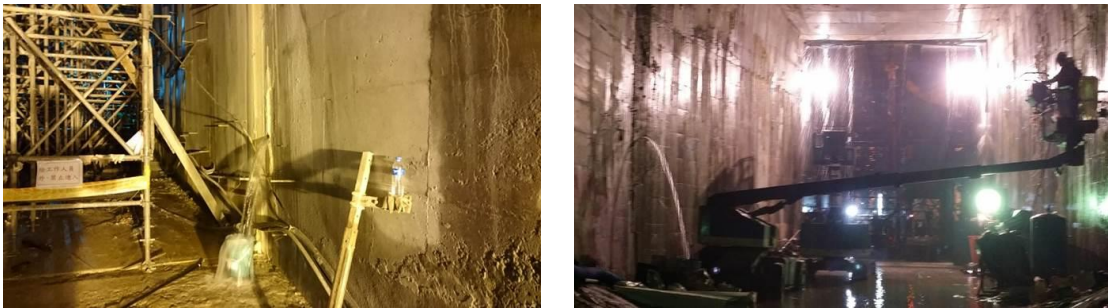
Figure 5: Water leakage of the lining during construction.

During the construction, the coated surface must be kept dry to effectively improve the bonding strength between interfaces. However, since the inlet section of the tunnel is adjacent to the reservoir area, leakage from the surrounding rock was encountered

during excavation. Most sections of the tunnel have adopted the water-stopping and the leakage-stopping techniques to keep the concrete lining surface dry, allowing the abrasion resistance material to be coated on the lining successfully. Nevertheless, few sections of the tunnel inlet are still affected by the leakage of surrounding rock caused by the high water level of the reservoir (Figure 5). After repeated pumping, water-stopping and surface-drying techniques, the abrasion resistance materials were successfully applied (BES, 2016).

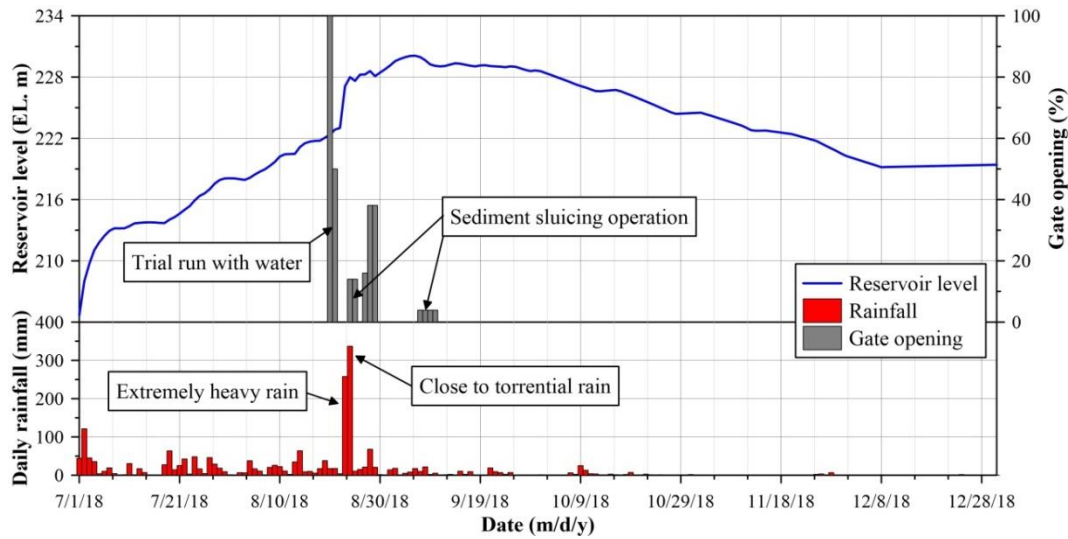
The ZRSST project was completed in November 2017, and the trial run with high-water level (EL.220 m or more) was carried out on August 20~21, 2018. Four sediment sluicing operations were conducted during the heavy rain period from August to September 2018. Figure 6 shows the relationship between the operation history of the tunnel, the regional daily rainfall and the reservoir water level.

Figure 6: Relationship between reservoir level and daily rainfall during the period of trial run with water and four sediment sluicing operations.

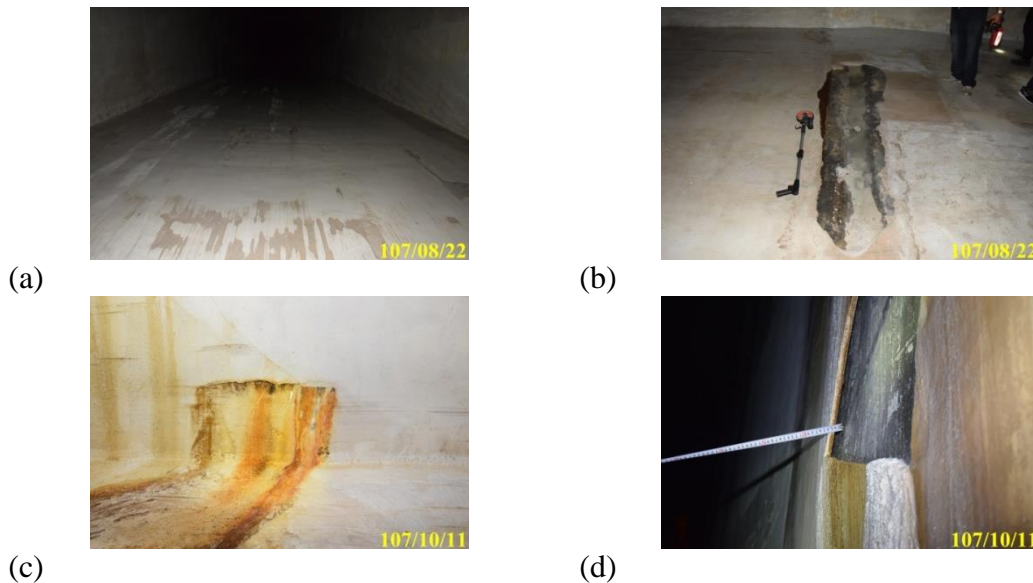
To understand the wearing condition of the abrasion resistance material after the trial run with water and the four sediment sluicing operations, in-situ inspections were carried out on August 22 and October 11, 2018. The inspection results show that the abrasion resistance material of invert has been worn down (Fig. 7a) and damaged (Fig. 7b). Moreover, water leakage (Fig. 7c) and spalling (Fig. 7d) phenomena were observed for the abrasion resistance material of the sidewall. The damaged abrasion resistance layer caused by the trial run with water and four sediment sluicing operations accounts for about 0.2% of the total abrasion resistance layer in the tunnel (UGI, 2018).

Figure 7: Photographs showing abrasion and damage in-situ after trial run with water and four sediment sluicing operations.

The in-situ inspection results show that the invert abrasion resistance layer of the ZRSST was damaged at the changing place of slope and flow velocity due to the impact of high mud-containing and concrete-containing water. Only partial abrasion was observed for the invert abrasion resistance layer. However, there was no significant difference in the abrasion resistance layer of the invert after four sediment sluicing operations. The water leakage and spalling phenomenon of the abrasion resistance layer on the sidewall is mainly caused by the heavy rain, leading to increased groundwater level and the increased moisture at the interface between the concrete lining and the abrasion resistance layer, which reduced the bonding strength.

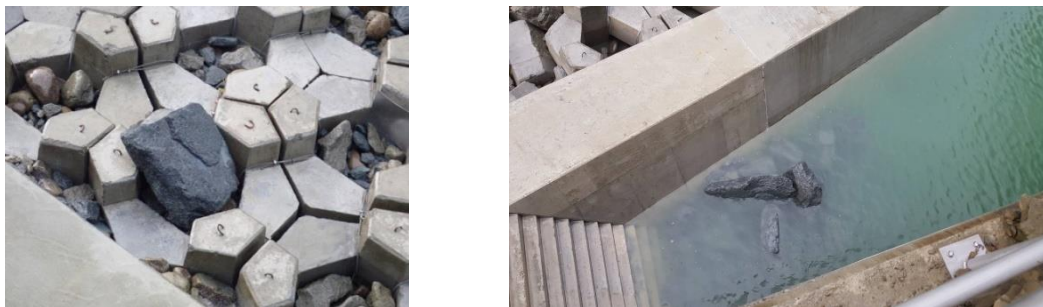
According to the in-situ inspection results, there are some concrete blocks remaining between the stilling basin and tetrapods of the outlet tunnel (Fig. 8). It is conjectured that such concrete blocks were piled near the inlet during the pouring of the underwater concrete in the elephant truck steel pipe section. Moreover, when the arc gate was raised from 60% to 100%, the increased flow rate may enhance the siphon effect, sucking the remaining concrete blocks into the sediment sluicing tunnel, which is then discharged together with the mud-containing water.

Figure 8: Photographs of concrete blocks in the outlet after trial run with water.

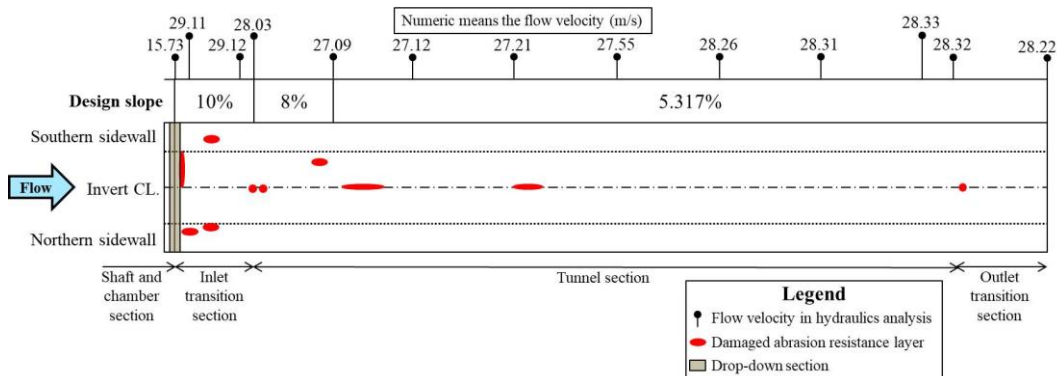
Figure 9 shows the relationship between the designed slope, flow velocity and damaged abrasion resistance layer of the ZRSST. The damaged abrasion resistance layer is concentrated in the inlet transition section and the front section of the tunnel section. The designed slopes of the two sections are 10% and 8%, respectively, which are the steepest sections from gate to plunge pool. In addition, there is a slope at the junction between the arc gate and the inlet transitional section. When the arc gate is opened, the high-speed muddy water containing concrete blocks will form a drop, which will increase the possibility of collision between the concrete blocks with the abrasion resistance layer, leading to damage.

Figure 9: Schematic diagram of designed slope, flow velocity in hydraulics analysis and damaged abrasion resistance layer.
