# Countermeasures against Sedimentation around Kurobe No.2 Power Station at Nekomata area in the Kurobe River, Japan.

Masanori Terada, Yutaka Tanaka, and Keita Kosaka

Keywords: Sediment Management, Countermeasure against Sedimentation, Kurobe River

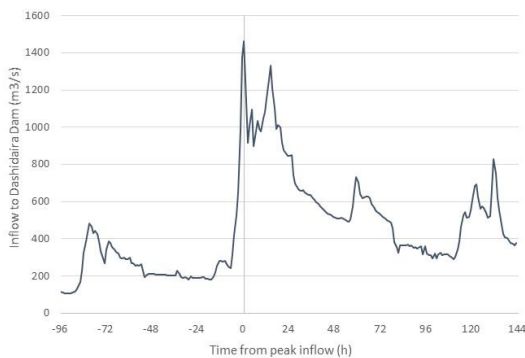
Fig.3 Inflow to Dashidaira Dam in the flood

In 1995, an extreme flood occurred in the Kurobe River. The inflow amount of Dashidaira Dam, located middle stream of the Kurobe river is shown in Fig.3. This flood caused serious damages on hydropower plants along the Kurobe River by debris flow as shown in Fig.4, including sedimentation around outlets, inundation on power stations, malfunctions of facilities and collapse of basement of railway running along the river. This flood was caused by seasonal rain from June to July and the amount of monthly precipitation was 1,354mm, which is quite large amount compared to average yearly precipitation of 4,000mm. There were several damages to generated facilities, , .

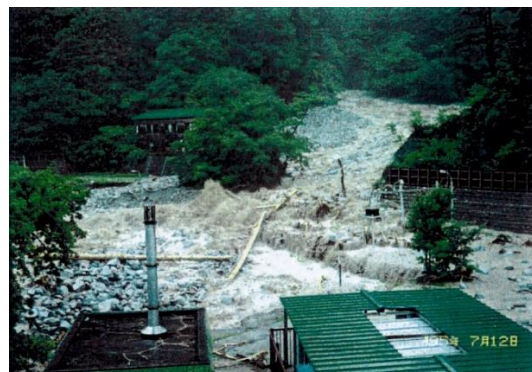
Fig.4 Debris flow from Nekomatadani

When the flood came in 1995, extreme debris flows were brought from these tributary (especially Nekomatadani) and these debris flows were the cause of terrible damage in Nekomata area. As a result, the flood in 1995 made extreme sedimentation, the river bed was raised up by 10m. Fig.6 shows the history of the river bed elevation around the area.

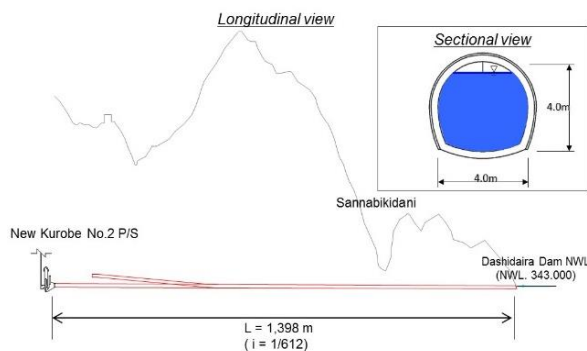
Fig.9 Longitudinal and sectional view

The length of new tailrace tunnel is about 1.4km from New Kurobe No.2 P/S to reservoir of Dashidaira dam where there is no impact from sedimentation and flood (Fig.9). New Austrian Tunneling Method (NATM) was adopted for the construction of the tunnel and a lining was constructed for the purpose of reducing water resistance.

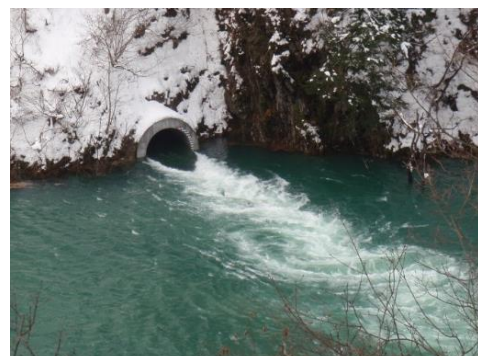
Fig.10 The outlet of tailrace tunnel

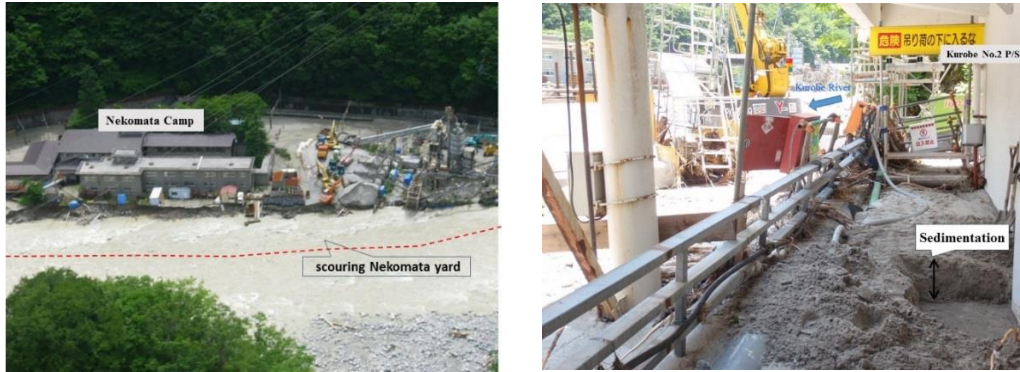
Fig.13 Damage by the flood in 2017

Kurobe river basin caused by seasonal rain early in summer which was developed by moisture wind from Typhoon. As a result, this flood gave terrible damages, inundation at the Nekomata camp, scouring and collapse of Nekomata yard, and sedimentation around the Kurobe No.2 P/S.
